## **MARINE INVESTIGATION REPORT**

**M99C0019**

### **GROUNDING**

**OF THE BULK CARRIER “HOPE I”  
OFF MORRISBURG, ONTARIO  
3 JUNE 1999**

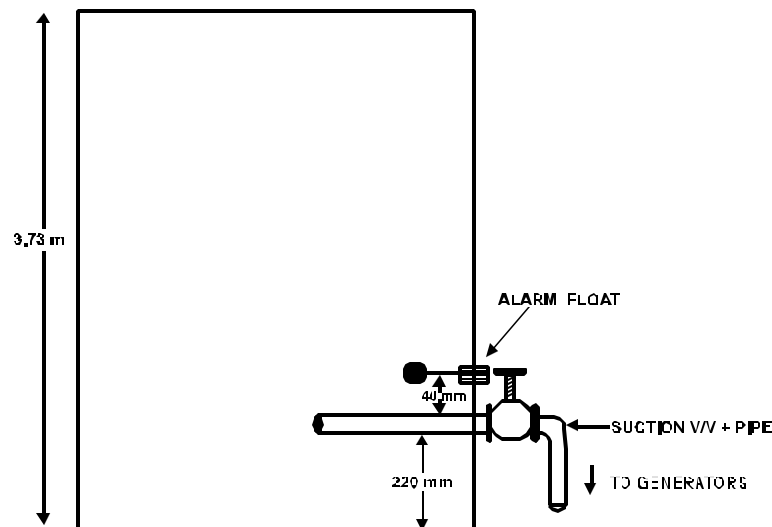
Arrangement of Generator Diesel Oil Service Tank

The engine-room staff were unaware that the generator fuel suction pipe arrangement in the service tank was such that the pipe extended straight into the tank on a horizontal plane, 220 mm from the bottom of the tank. Because of this arrangement, the last 1.8 tonnes of fuel in the tank was unusable. The float for the low level alarm was located 40 mm above the fuel suction pipe.

Besides the low level alarm, there was no provision in the engine-room for determining the level of fuel in the generator service tank. Instead, a crew member had to leave the engine-room and sound the tank from a location on the main deck forward of the accommodation.

The engine-room staff was not aware that the internal arrangement of the generator service tank was such that the fuel below the suction pipe was unusable, the tank sounding tables did not indicate that this was the case, and reliance was placed on soundings which showed that there were about two and a quarter tonnes of fuel remaining in the tank. These factors combined to influence the engineer's decision to ignore the low level alarm. However, the combination of the known average fuel consumption and the low level alarm, reinforced by the 1000 sounding, should have provided ample warning that the level of fuel in the generator service tank was critically low.

3. There was no appropriate means of determining the amount of diesel oil in the generator service tank from inside the engine-room. The engine-room staff were not aware that the internal arrangement of the generator service tank was such that the last 1.8 tonnes were unpumpable.

Subsequent to the occurrence, a low fuel level notation was added to the Alternator Service Tank sounding tables on board the vessel.

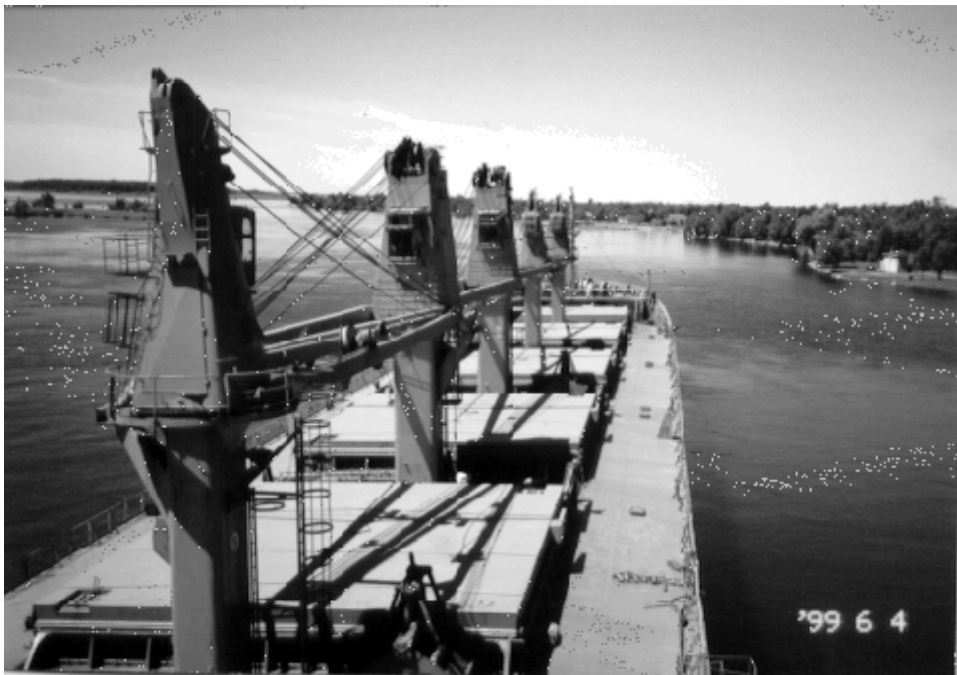
vessel was sheering to port out of the channel. At 1240, the vessel grounded at position 44°53.53' N, 075°10.74' W in front of the government wharf at Morrisburg.

Photo 2  
"HOPE I" aground at Morrisburg, Ontario

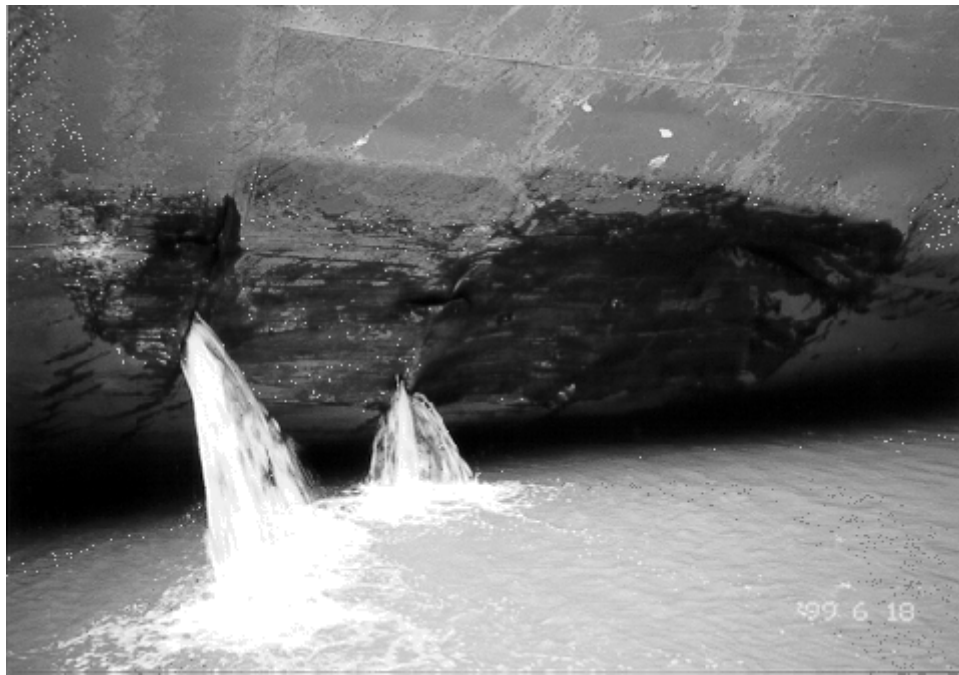
The master immediately ordered the sounding of all tanks, which revealed that the No. 1 port lower hopper ballast tank and the forepeak tank were taking on water. Subsequent inspection by divers confirmed that the vessel was damaged on the port side between frames 224 and 230, 2 m above the bottom in the lower hopper tank, and at frame 237, 3 m above the bottom in the forepeak tank.

Photo 4  
Hull damage caused by grounding
